# Subsidence in the Chalk

## Using seismic tomography

by Peter Jackson, David Gunn, Robert Flint, *Keyworth*,  
Michael Bent, *1st Ground Investigations & David Howes*,  
*Broad and Gloyens, Consulting Engineers*

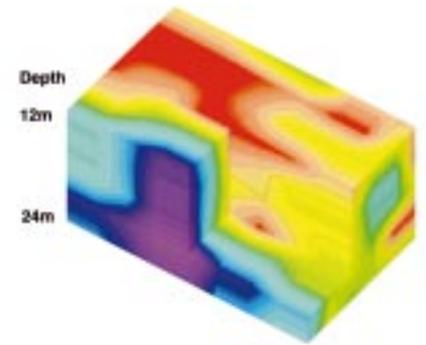
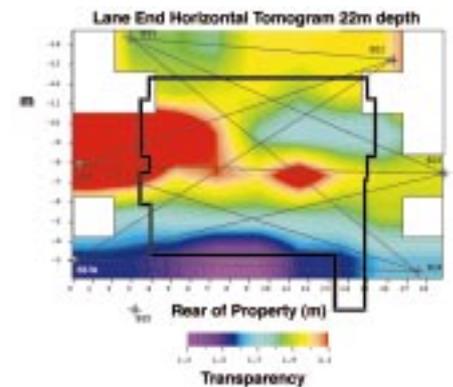
Seismic tomography identified an 'opaque' volume of ground (high attenuation) to be associated with the subsidence and to extend under the rear of the property.

The results showed seismically 'opaque' ground (blue) to extend under the rear of the property to a degree that implied the ground under the house was likely to subside. The outcome was that the proposed remedial measures were deemed to be too expensive, and a new solution was formulated.

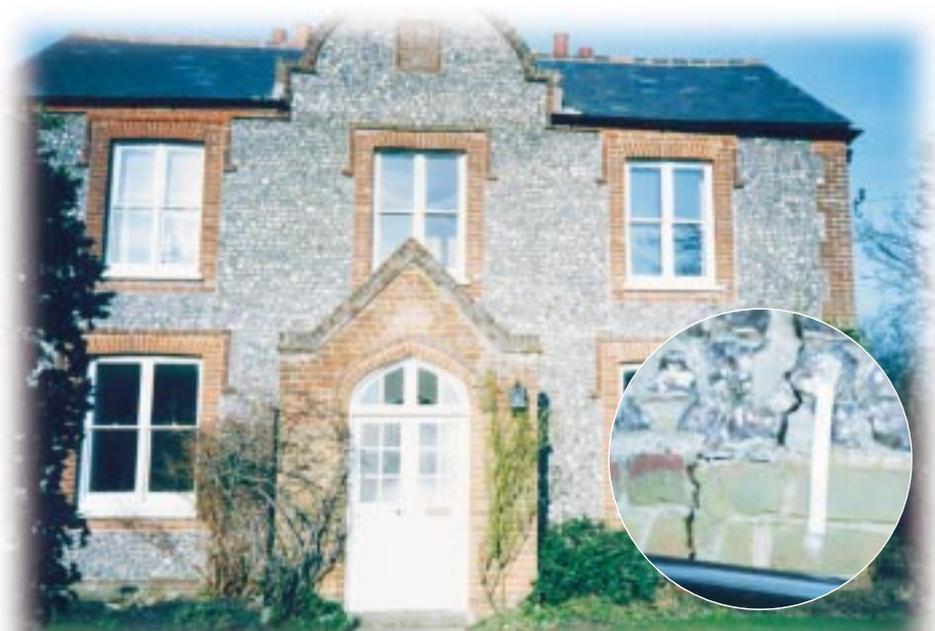
Subsidence over the period 1993 to 1997, at the rear of a property near High Wycombe built in 1830, resulted in substantial cracking of the masonry structure. In order to design remedial measures, knowledge of the extent of disturbed ground beneath the dwelling was necessary. Cross-borehole seismic tomography was identified as the most suitable means of assessing the ground beneath the property without disturbing it.

Main photo: *The Old Vicarage built in 1830.*

Inset photo: *Cracks in external masonry.*
