Collapsing loess soils

An under-appreciated hazard

by Kevin Northmore, *Keyworth*, Ian Jefferson, Ian Smalley & Caroline Tye, *Nottingham Trent University*

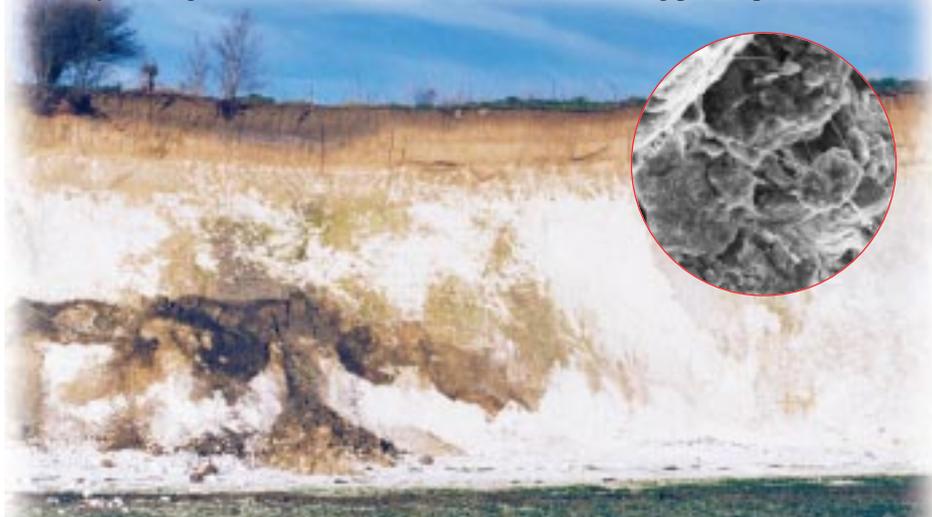
Main photo: *Pegwell Bay, Kent the best-known loess site in the UK. Cliff section shows 3 m of brown loess overlying the Chalk.*

Inset photo: *A scanning electron micrograph showing the typical macroporous structure of loess from Pegwell Bay, Kent. The view shows silt-sized quartz particles coated with clay minerals which 'bond' the particles together making a metastable structure. The hair-like 'cobweb' features represent the early stages of cementation by calcite. The clay and calcite bonds break down when the sample is loaded and wetted causing collapse of the soil structure into void spaces.*
