# Cliff stability and coastal landslides

## Rock slide at Beachy Head

by Alan Forster, Peter Hobbs & Robert Flint, *Keyworth*

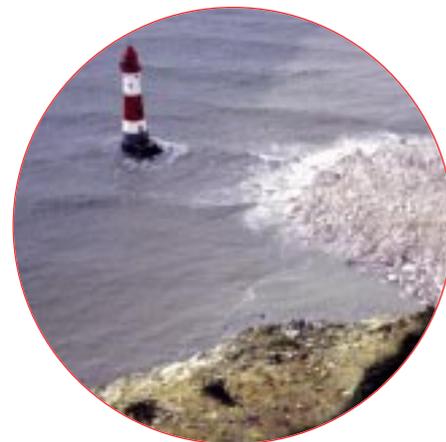
*The January rock slide almost reached the base of the Lighthouse.*

**O**n the 10/11th of January 1999 a rock slide at Beachy Head, East Sussex, took place that received considerable media interest due to the relatively large size of the fall and the prominence of Beachy Head as a tourist attraction. The fall also disrupted the electricity supply to the Beachy Head Lighthouse, founded on the wave-cut platform at the bottom of the cliff, and required deployment of the backup diesel generator.

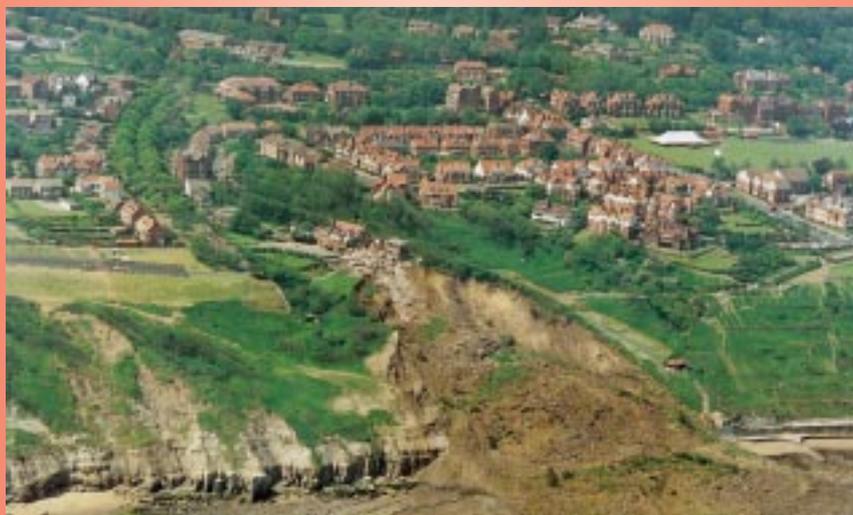
A large slump in glacial till led to the destruction of the Holbeck Hall Hotel, Scarborough in June 1993.

interest when it destroyed the Holbeck Hall Hotel in 1993. A rotational landslide involving about 1 million tonnes of glacial till cut back the 60 metre-high cliff to a distance of 70 metres. It flowed across the shore to form a semicircular promontory 200 metres wide projecting 135 metres outward from the foot of the cliff. The cause of the slide was attributed to heavy rainfall of 140 millimetres in the two months before the slide took place.

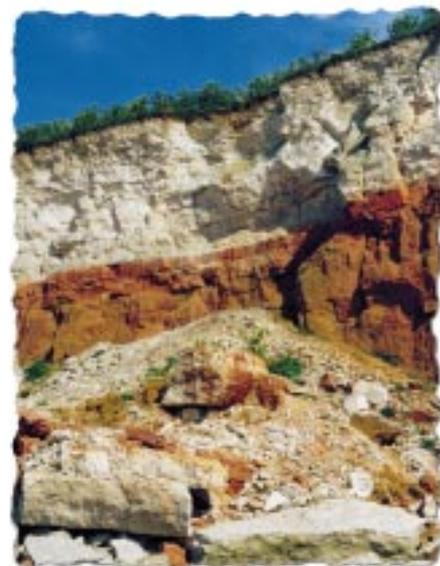
Although only the large and spectacular landslides are reported in the news, small landslides are common around our coast and affect a wide range of geological materials such as soil falls and slides in the low till cliffs of Holderness, rock falls from the strikingly coloured red and white chalk cliffs at Hunstanton (*above*) and mudflows from the internationally famous fossiliferous Jurassic cliffs of the Dorset coast.

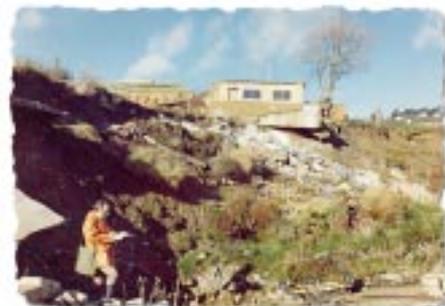
It is important to take into account the possibility of rock falls from cliffs when enjoying the recreational potential of our coast both by being careful to avoid walking at the edge of unstable cliff tops and taking care to keep away from the base of cliffs which have overhanging rocks on the point of falling. On a larger scale, all construction work near to cliffs should take expert advice on cliff stability issues at the time of construction and projected into the design life of the structure being considered. The cost of such surveys and predictions is money well spent as illustrated by the bungalow at East Cliff, Dorset (*above*) that was carried over the cliff edge by landsliding about one year after its completion.

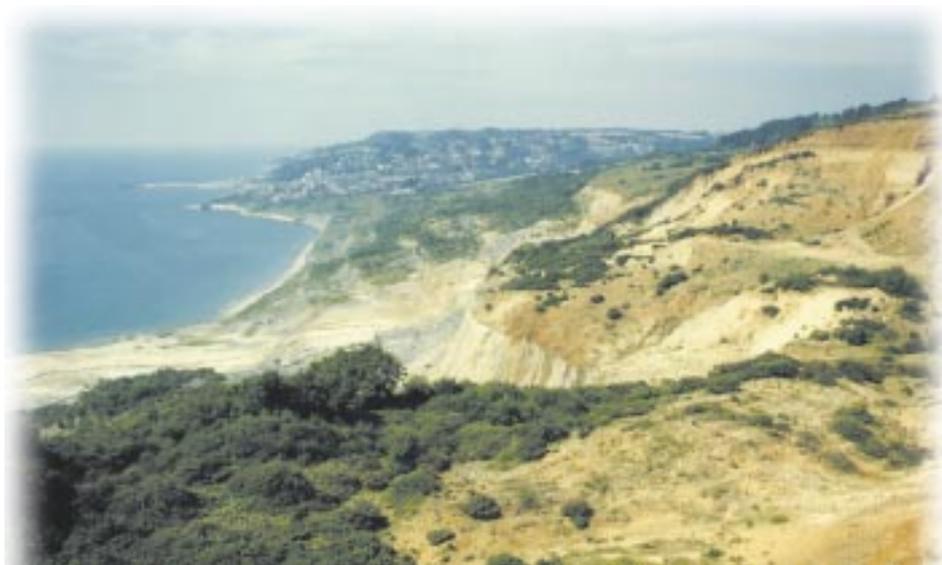
Mudflows of Lias clay and sand runs from the Upper Greensand form the Black Ven landslide complex on the Dorset coast, east of Lyme Regis.
