Tsunamis and the urban environment

Implications for national and regional planning

by David Gunn, Martin Culshaw, Alan Forster
& Peter Jackson, *Keyworth*

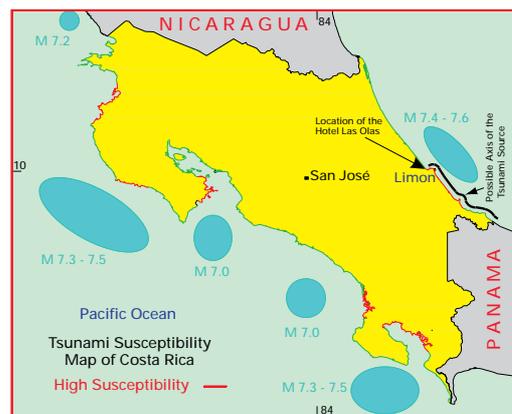
The tsunami risk to the coastline of Costa Rica is indicated, along with the location of the axis of the source for the 1991 tsunami. The light blue areas are potential seismic sources with estimates of magnitude.

The coastal topography of Costa Rica is varied, ranging from low-lying coastlines and enclosed playas (beaches), through rocky headlands fringed with coral reefs to coastal cliffs in hard rocks. The low-lying coastlines and playas are most vulnerable to inundation from the run-up of a tsunami and the rocky headlands with coral reefs are most vulnerable to flooding by a tsunami overtopping a high protective structure. Assessing the susceptibility of these areas to the tsunami hazard begins by considering the likelihood of a particular section of coastline being in the proximity of an offshore seismic source. Such maps can readily be drafted by a seismologist. As an example, the Tsunami Hazard Susceptibility Map for Costa Rica offers a first look-see at the risk to the coastline from the tsunami hazard. This is

very useful for National Scale Planning as it quickly characterises the coastline tsunami susceptibility into the three broad categories of low, medium and high. While planning at the national scale, it can readily be seen that coastal areas near to potential seismic sources, shown as light blue areas with an estimate of magnitude, represent a high risk where more detailed planning cannot be

avoided. Such high risk areas are the low-lying playas on the Caribbean coast to the south east of Limon where a magnitude 7.5 earthquake caused a tsunami in 1991.

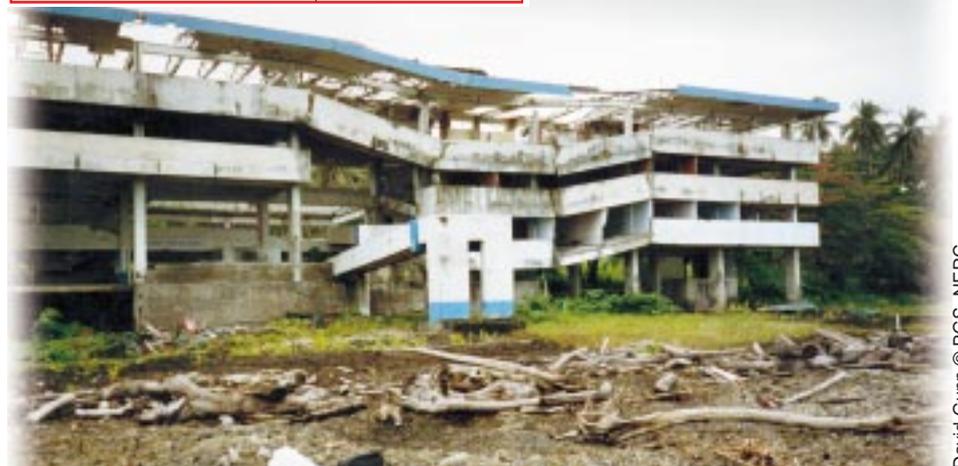
The exposed coral reef in front of the Hotel Las Olas indicates the pre-earthquake shoreline.

The tsunami struck the coast between Limon and the Panamanian border. Tsunami arrival times along this section of the coast were generated about the axis of maximum uplift which runs parallel to the coast between three and eight kilometres offshore in seawater of approximately 50 metres depth. The axis of uplift intersects the shoreline just to the north of Limon where it caused the sea to retreat by 75 metres. It also completely destroyed buildings on the shoreline like the Hotel Las Olas featured in the photograph.
