Lancashire landslides

Integrated mapping of potential geological hazards

by Dick Crofts

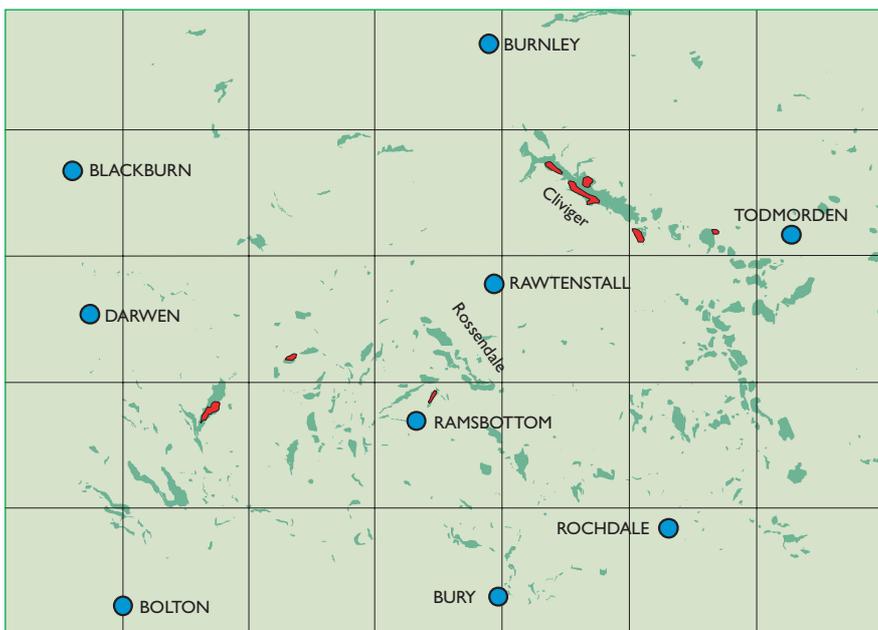
Map of east Lancashire indicating over three hundred individual landslides which have been identified following the recent resurvey (dark green areas). The previous survey in the early 1920s identified only eight areas of landslide over the same area (red areas). The survey was supported by archival research and the interpretation of aerial photographs.

the resurvey will provide fit-for-purpose geological maps. The previous survey in the early 1920s identified only eight areas of landslide over the 600 square kilometres of the Rochdale Sheet. Following our recent survey the number of individual landslides identified has increased to over 300 (see map, *left*). The area affected by an individual slide can range enormously in scale from less than five hundred square metres to over three square kilometres. Many occur close to urban areas and may have a bearing on future development.

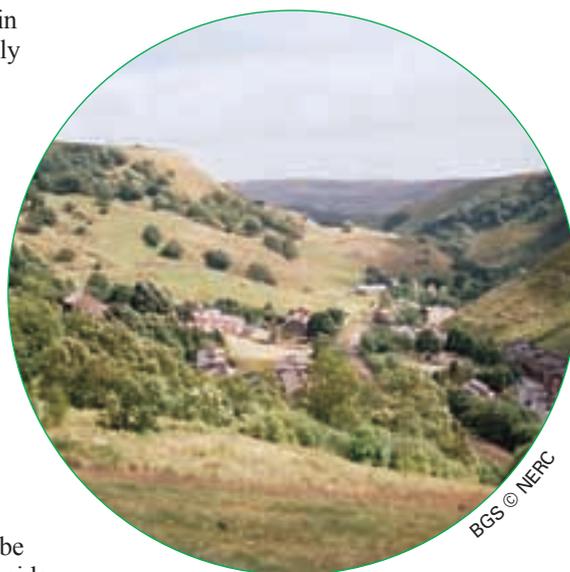
Landslides in the Cliviger Valley near Cornholme.

During the last ice age, these faults would have been subject to pressure from the overlying ice. As the pressure was released the partially unsupported footwall often collapsed in large rotational failures. This action has initiated some of the slides in the northern part of the Cliviger Valley and, to a lesser extent, in the Naden Valley north-west of Rochdale.

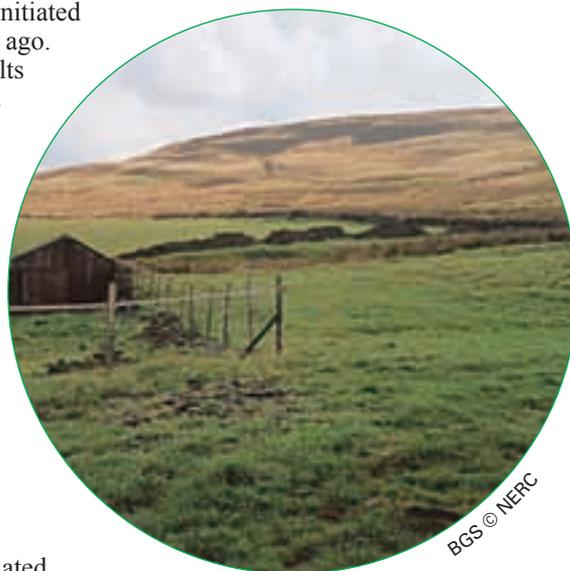
Landslides on the south side of the Rossendale Valley.

1000 metres of ice, rather like Greenland today. As the ice melted, the pressure on the underlying rock was released while, at the same time, large volumes of water were freed. Over-steepened valleys were produced by the ice and escaping waters as, for example, in the Walsden and Rossendale valleys, and most spectacularly in Cheesden Brook and Cliviger. With the supporting ice removed, the valley sides collapsed, often quite catastrophically. Material cascaded down the steep slopes, leaving a rock scar at the highest point and a mix of sandstone and mudstone blocks in a jumbled mass to the valley floor. Many of these areas quickly stabilised and have generally not moved in the past 10 000 years.
