While Britain has benefited from mined wealth for centuries, historical mining activity has left a hazardous legacy of unrecorded shafts. These are now being revealed using cutting-edge imaging techniques. **Jon Chambers, Richard Ogilvy, Paul Wilkinson, Alan Weller, Phil Meldrum (all BGS) and Simon Caunt (Coal Authority)**

Locating lost mineshafts

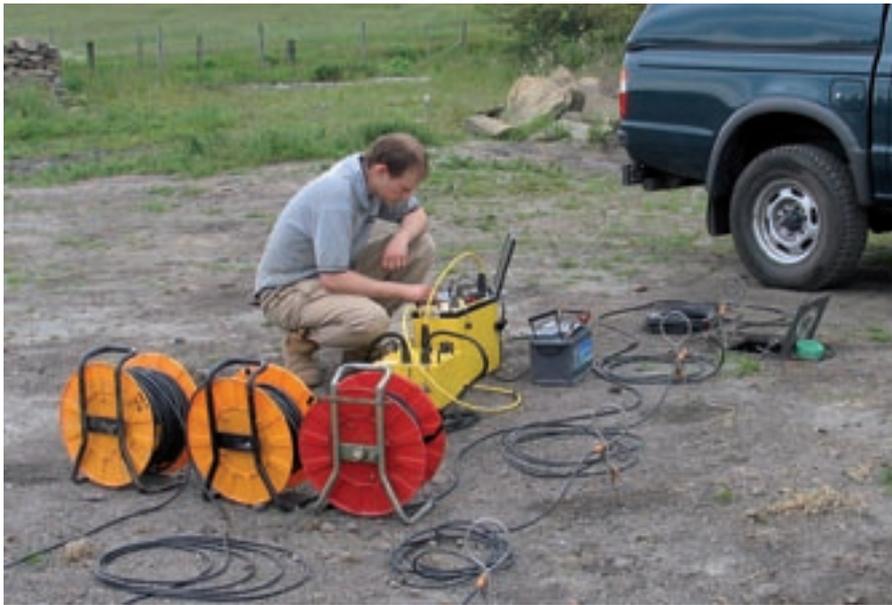
A resistivity imaging survey in progress.

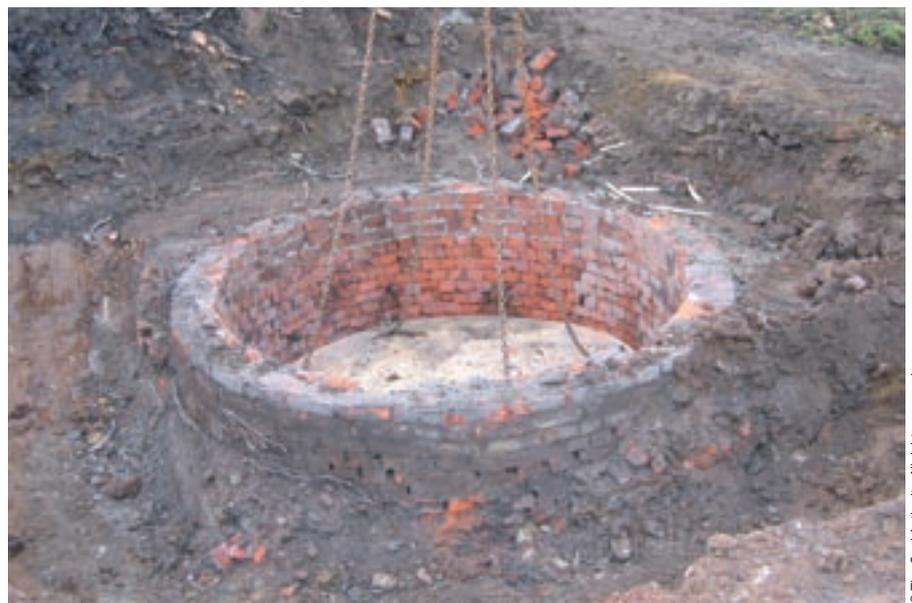
An abandoned mineshaft prior to capping.
