Building stone forms a significant component of the fabric of our towns and cities. However, as **Ewan Hyslop** and **Andrew McMillan** explain, even stone doesn't last forever and without proper care this important element of our cultural heritage is under threat.

Our crumbling buildings

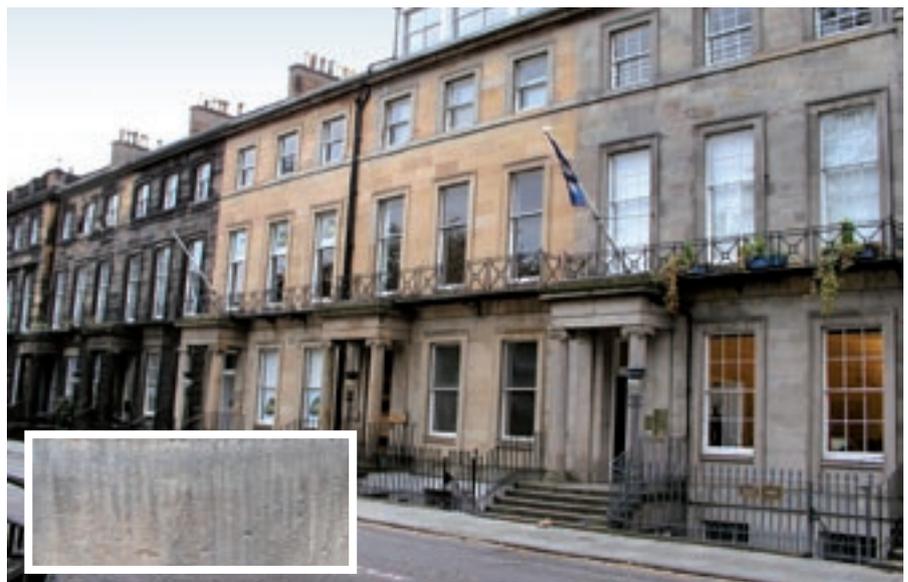
Typical sandstone buildings showing variable appearance due to the use of different stone cleaning techniques. All the buildings are constructed from the same stone type. Inset shows damage to stone masonry surface due to the application of corrosive cleaning chemicals.

Significant damage to sandstone buildings has been done by stone cleaning, where the action of corrosive chemicals and abrasive methods

has removed the external protective hard patina, exposing weakened underlying layers of stone which are prone to relatively rapid weathering. The introduction of expansive salts, during chemical cleaning, into the pore structure of sandstone has resulted in irreversible damage to the fabric of many stone buildings. New research is being targeted to determine the detailed damage mechanisms and to understand the effects of increased rates of decay on damaged stone in the face of climate change. The BGS has initiated two Ph.D. studentships specifically to investigate these issues.
